June 20, 1996

On Thursday May 30, 1996 we conducted an inspection of the Atlas mine site. The purpose of this inspection was to evaluate remedial activities recently completed by the responsible party (RP), determine if additional improvements are necessary, and identify areas of the site that could be revegetated. Participants were:

SKETCH OF ATLAS SITE
DRAINAGE IMPROVEMENTS
OBSERVATIONS FROM
5/30/96 INSPECTION

=====
Client: U.S. Environmental Protection Agency E&E Job No.: ZM6000
Site: Atlas Asbestos Mine Site 5/30/96
Camera: Make Yashica AF-mini SN N/A
Lens Yashica AF-mini SN N/A
=====

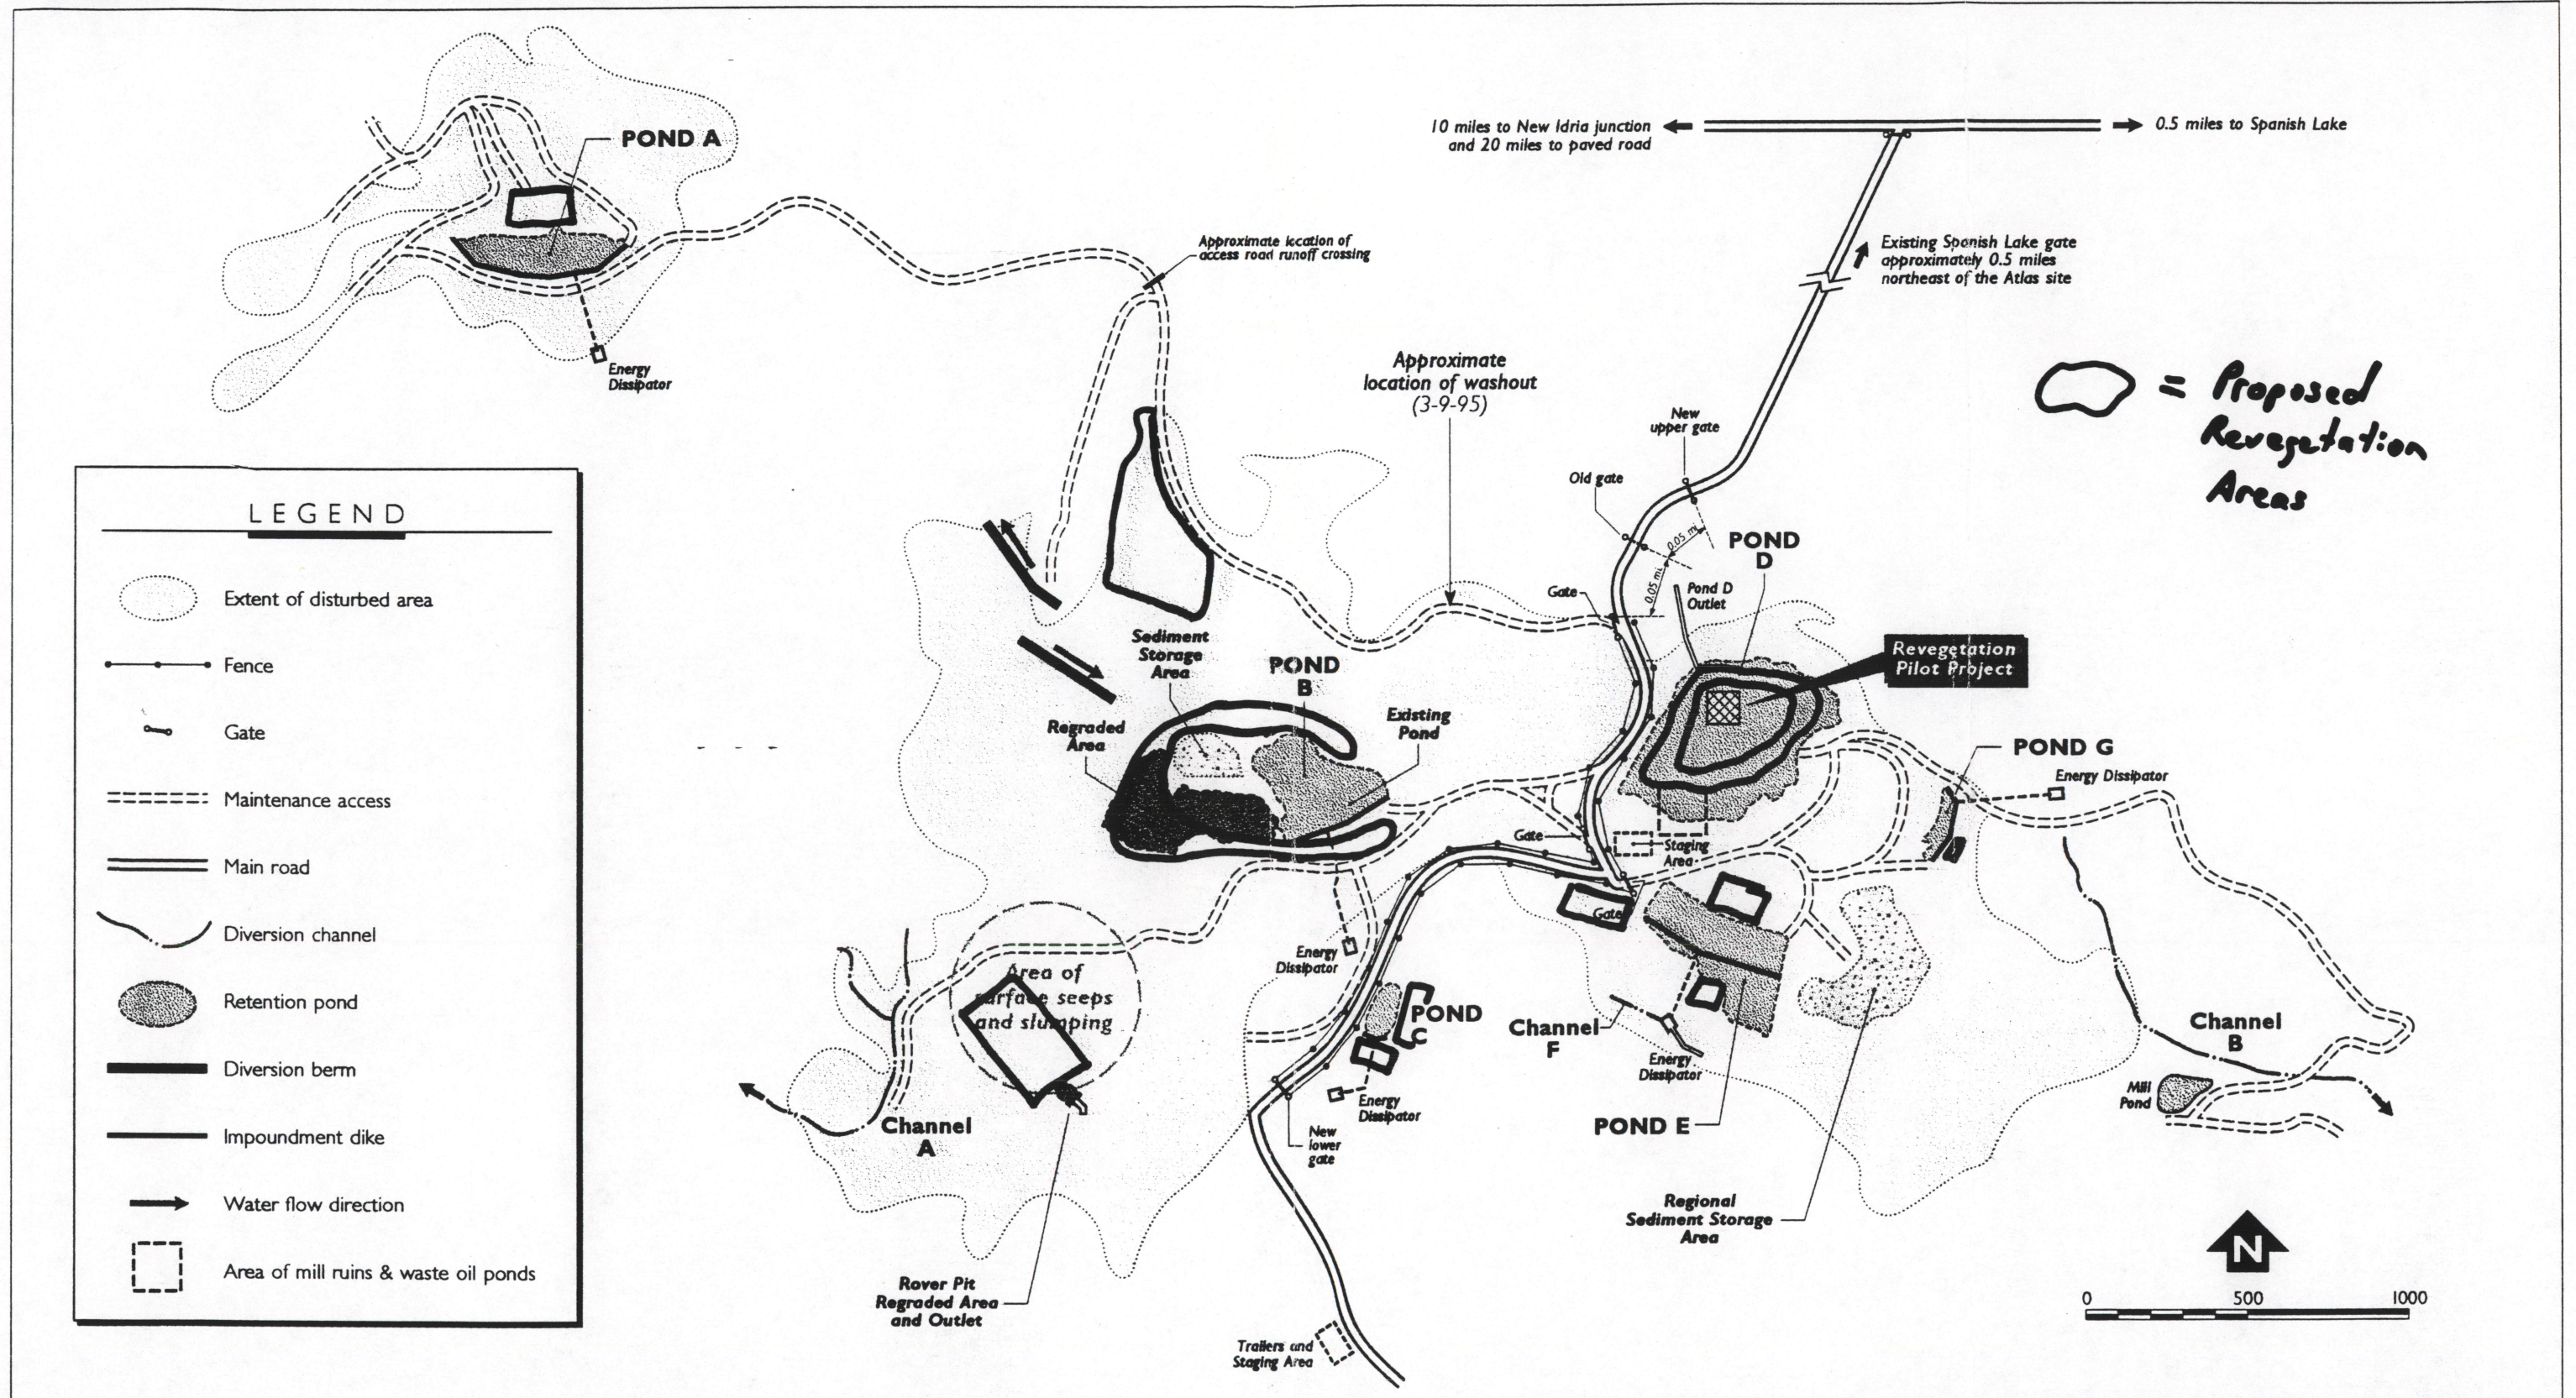
Figure 1 **EXISTING and PROPOSED FEATURES**
Atlas Mine Superfund Site
 Coalinga, California

- c) Road drainage - Road drainage has been improved on both sides of the chip sealed road near the entrance to the mill area (see attached sketch). The RP will need to cut a ditch from the upper mine road to induce runoff into the drainage ditch west of the chip sealed road (see photograph 1). Drain rock placed where the drainage ditch west of the chip sealed road crosses the access road to Pond B should be redistributed allowing flow across the access road (see photographs 3 and 4). The diversion berm

installed where the drainage ditch turns sharply to the west should be armored to reduce erosion.
